Manhole Inspection Summary

Manhole # S35A__019MH

Insp Date: **11/14/07 8:38 AM**

Location Address: **649 st.paul st**

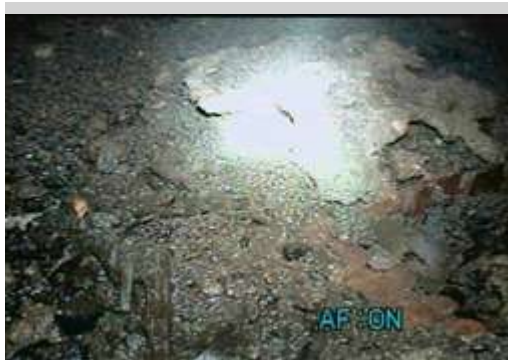
Misc

bench debris

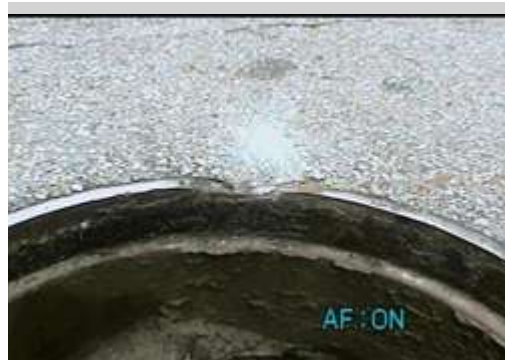
Defect 4

Frame Offset: **2** (in.) Condition: ☐ Sound ☒ **Cracked** ☒ **Leaks**

frame cracked and leaks

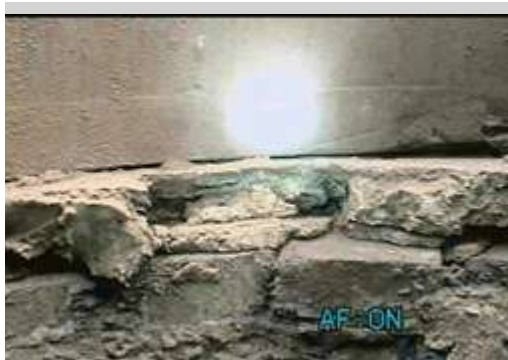
Defect 3

Condition: ☐ Sound ☐ Cracked ☐ Root Intrusion ☒ **Loose Brick** ☐ Deteriorated

loose bricks, frame adj

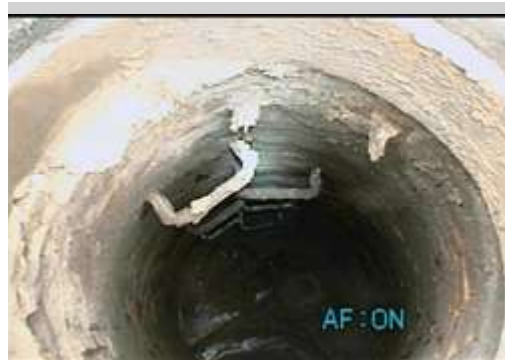
Defect 2

Steps Count: **8** Missing: **1** ☒ **Corroded**

steps

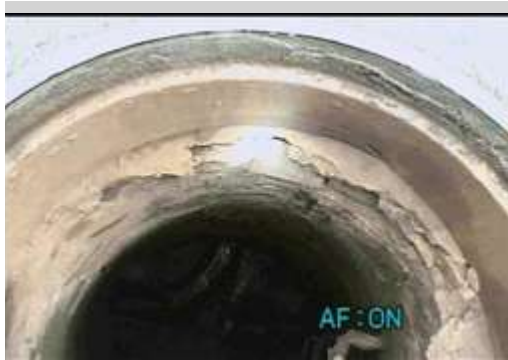
Defect 1

offset
